STRUCTURES INSPECTION FIELD REPORT

C-05-010

ROUTINE INSPECTION

CITY/TOWN CHARLEMONT	8-STRUCTURE NO. C05010-0EQ-MUN-NBI	11-Kilo. POINT 041.520	41-STATUS A:OPEN	90-ROUTINE INSP. DATE JUN 19, 2017
07-FACILITY CARRIED ST 8 A/W HWLEY RD	MEMORIAL NAME/LOCAL NAME	27-YR BUILT 1944	106-YR REBUILT 0000	YR REHAB'D (NON 106) 0000
06-FEATURES INTERSECTED WATER DEERFIELD RIVER	26-FUNCTIONAL CLASS Major Collector	DIST. BRIDGE INSPECTION ENGINEER L. A. Briggs <i>L. A. Briggs</i>		
43-STRUCTURE TYPE 402 : Steel continuous Stringer/Girder	22-OWNER Town Agency	21-MAINTAINER Town Agency	TEAM LEADER M. A. Adorno <i>M. A. Adorno</i>	
107-DECK TYPE 1 : Concrete Cast-in-Place	WEATHER Rain	TEMP. (air) 25°C	TEAM MEMBERS R. MANCARI <i>RM</i>

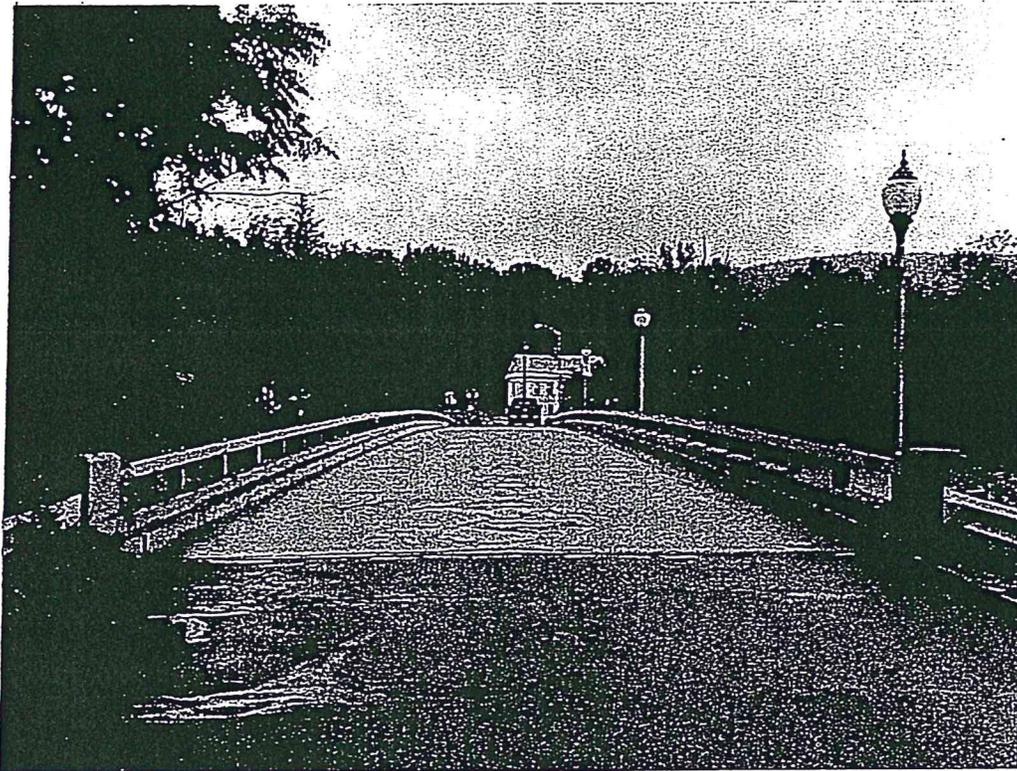
The wearing surface has failed exposing 90% the deck. See photos 1 & 3.

The exposed deck has numerous potholes and with exposed rebar throughout the wearing surface, up to 3" diameter x 2" deep. Some of the potholes have been patched. See photos 1 & 3.

Photo 1: General topside view, looking north.

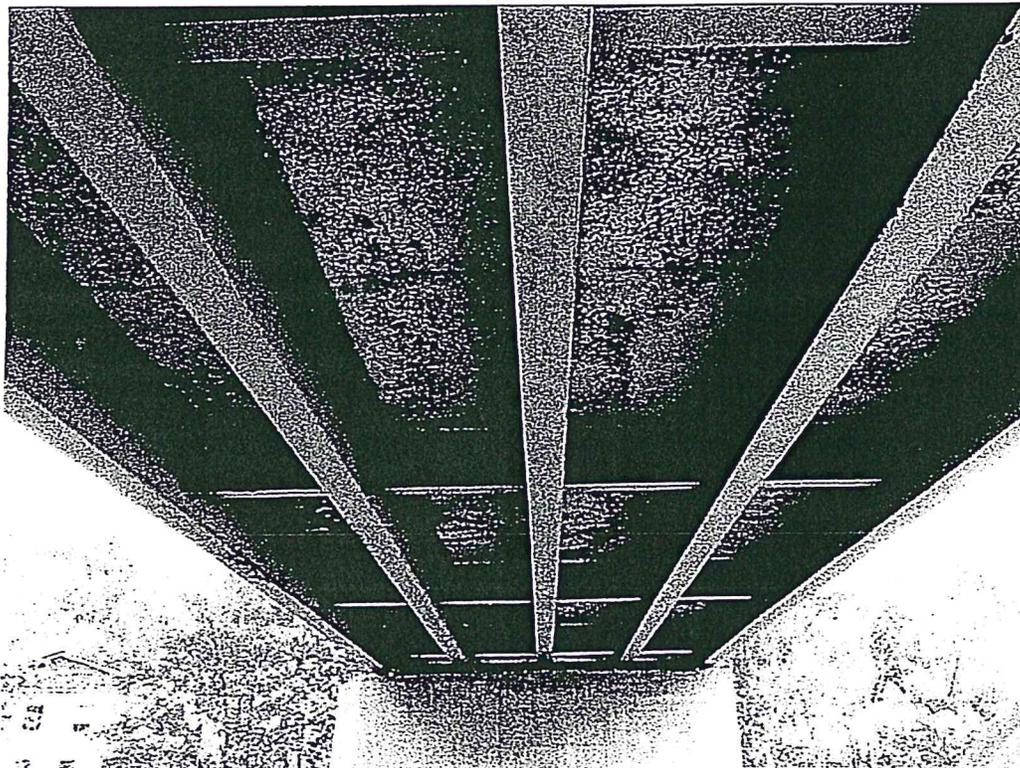
Both fascia beams, below the deck drains, and all beam end as the south abutment, have areas of failing paint. The remainder of the paint is dull and chalking. See photos 2 & 8.

Photo 2: Typical underside view, span 3 looking north shown.

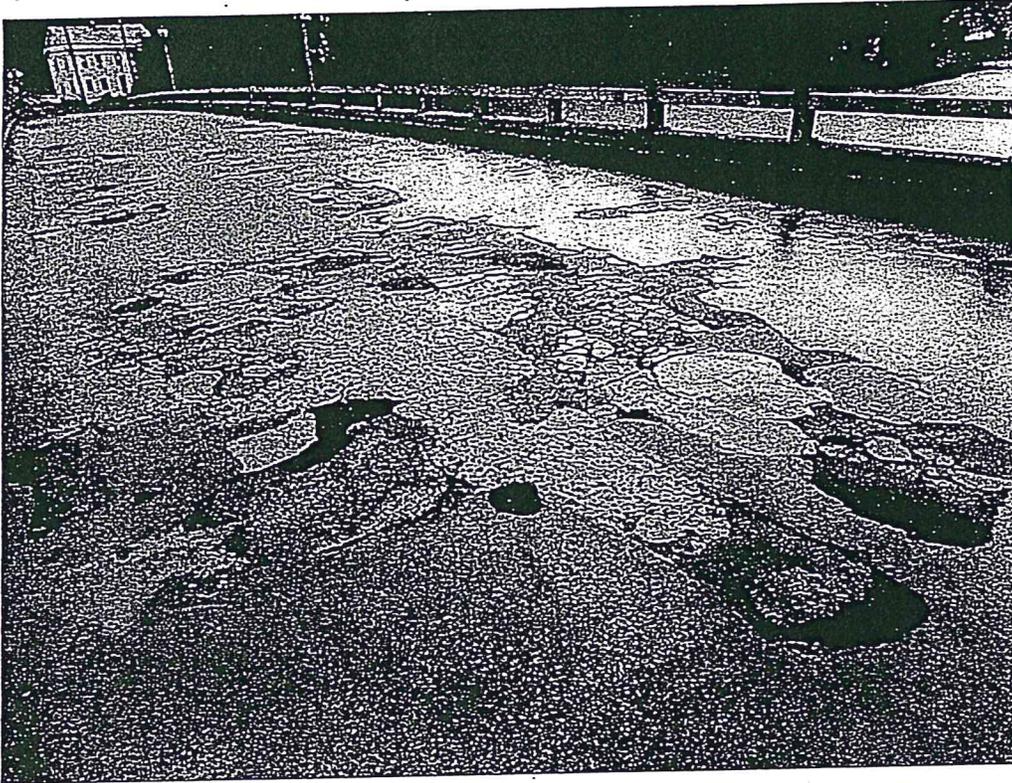
Photo 3: Typical condition at the deck topside with numerous spalls and patches. Note failed wearing surface.

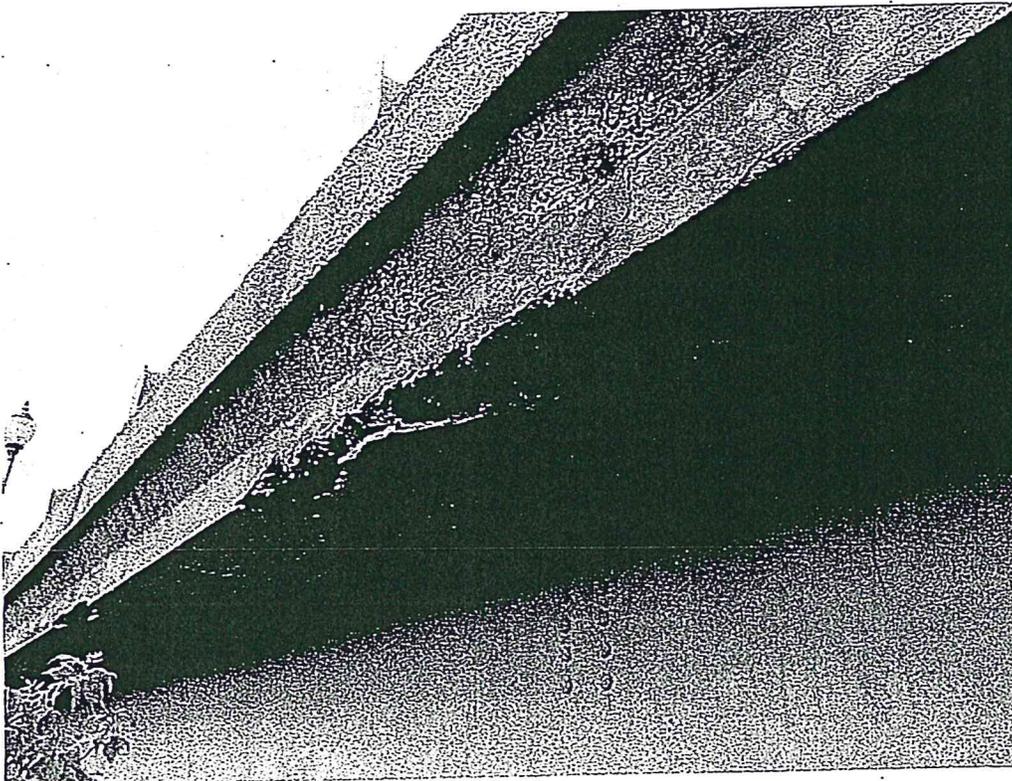
Throughout both deck overhangs, the concrete is spalling with exposed rebar, up to full width x 3" deep. These spalls occur primarily around the deck drains. See photos 4 & 5.

Along both curblines, the drain holes are spalling. This spalling extends into the deck underside. See photos 4 & 5.

Photo 4: Typical spalling around the deck drains, before concrete removal, span 1 east overhang shown.

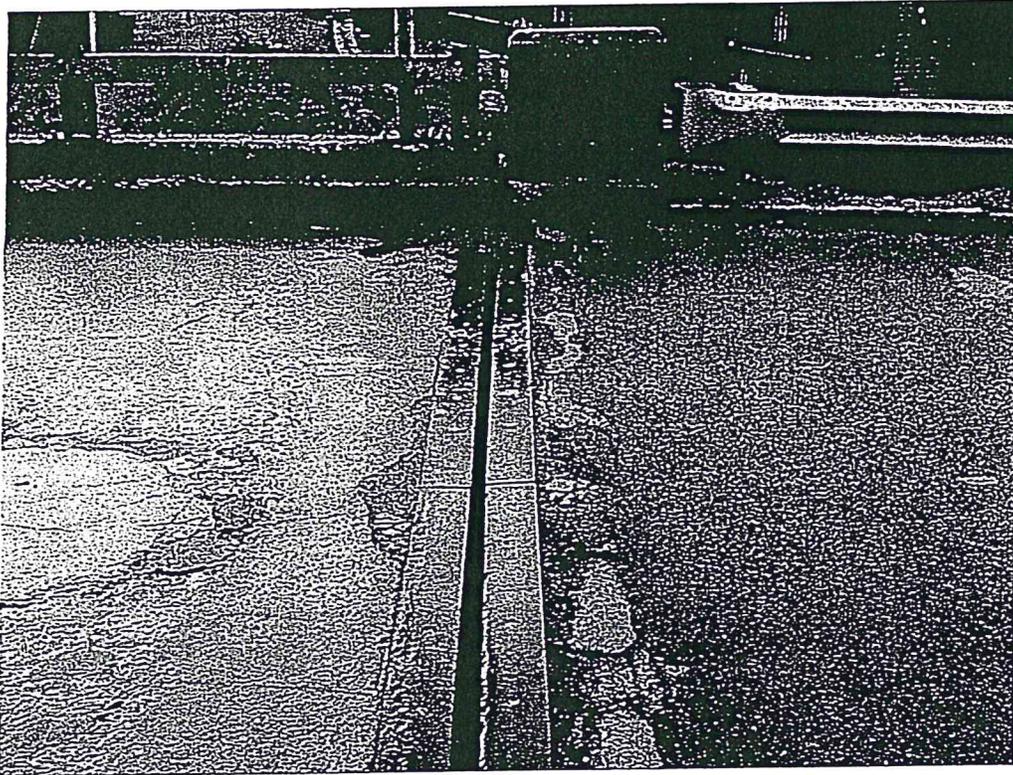
The south compression joint seal has failed allowing leakage and debris to fall onto the seat below. See photos 7 & 8.

Photo 7: South compression joint seal failed.

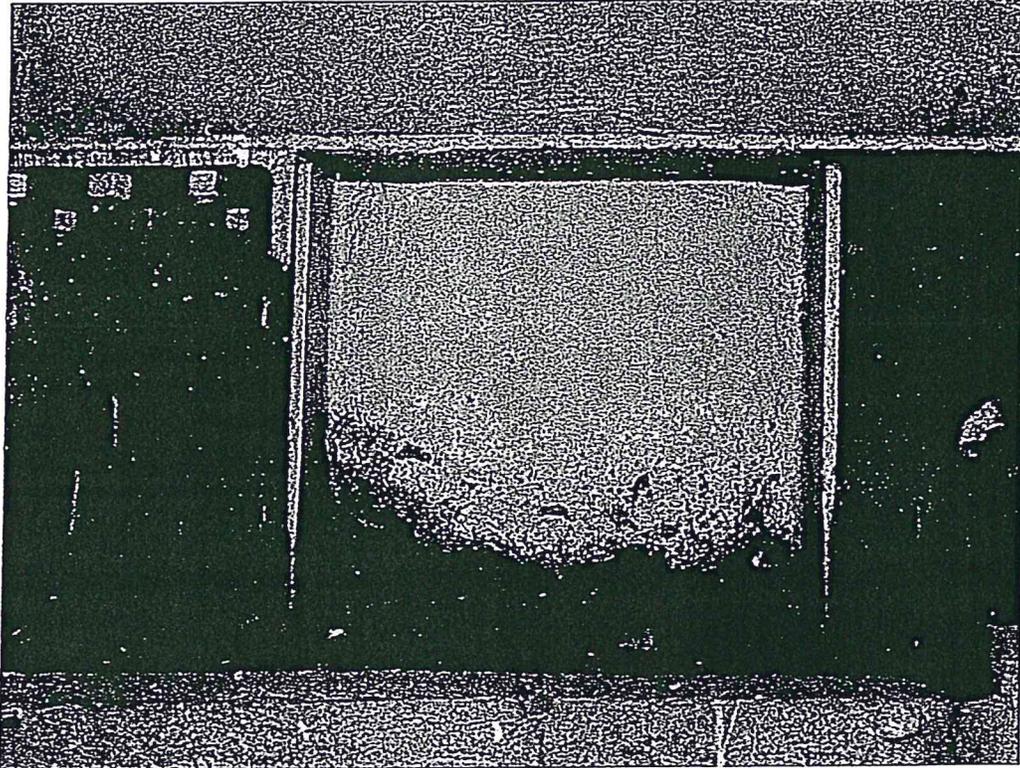
At both abutments and at pier 1, in bay 1, the keepers have severe corrosion with large holes. See photos 9 & 10.

Photo 9: North abutment, bay 1, flood lock with section loss and holes

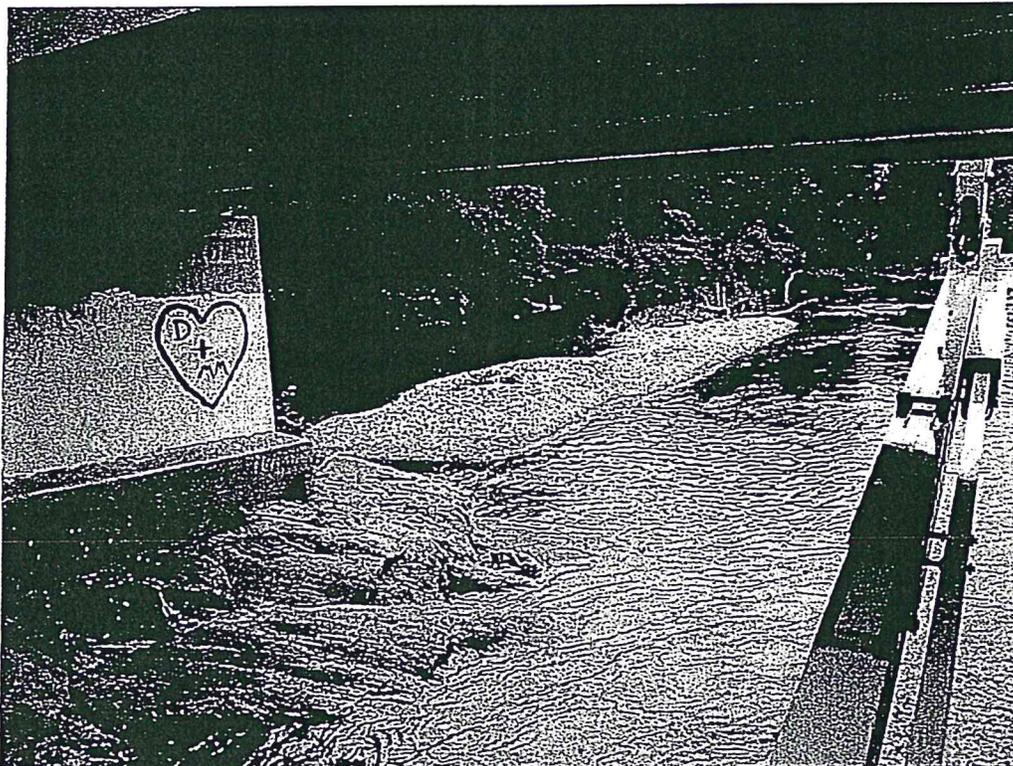
Photo 14: Aggradation bar downstream.

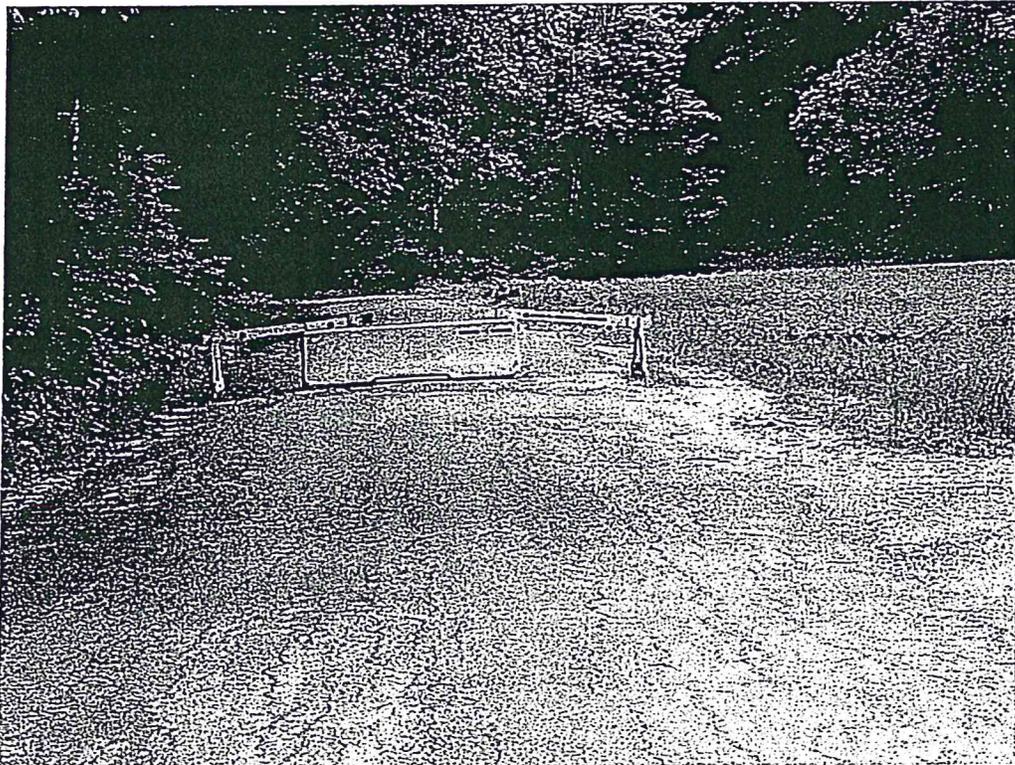
Photo 2: South advance barrier and wooden barricade. Note, vehicle tracks around the barricade.

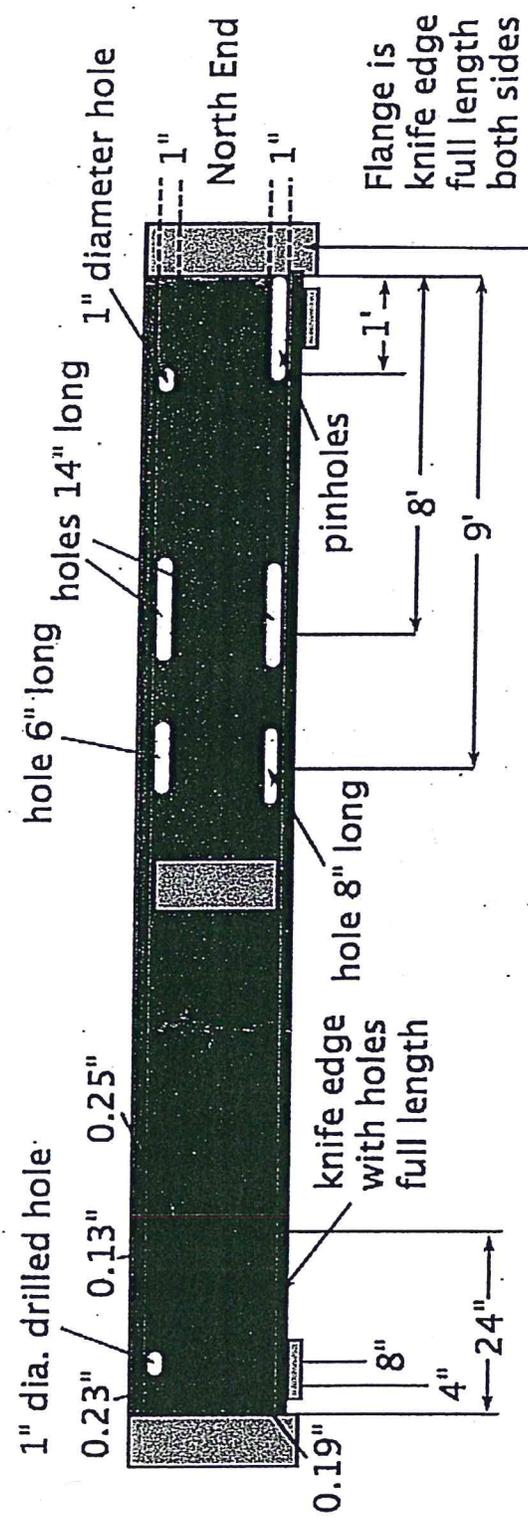
# Beam 1 East Elevation

Reinforced Concrete  
 encasement (typical at both beam ends)  
 full height x 8" wide x full width of the bay

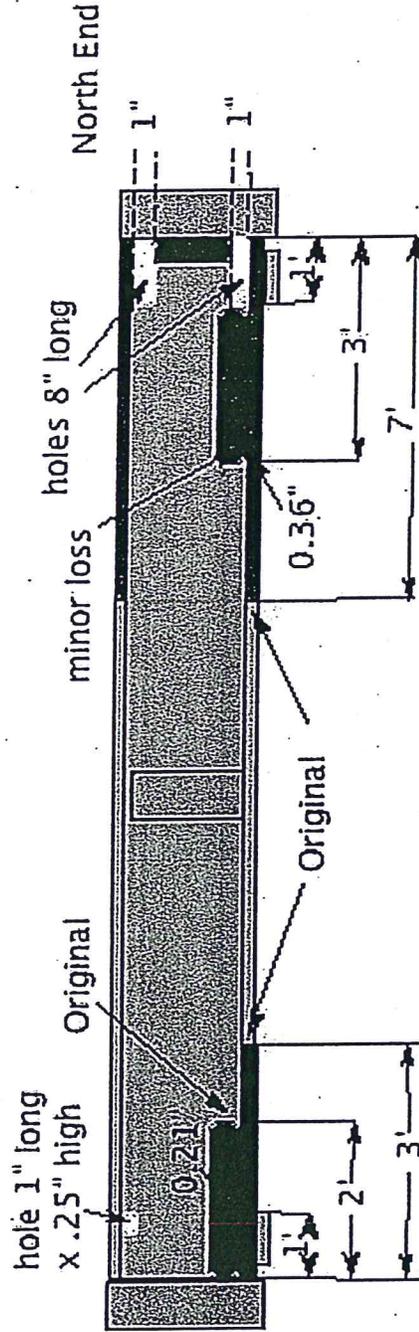
**Beam 4  
West Elevation**

Both flanges knife edge  
with holes @ bearing face

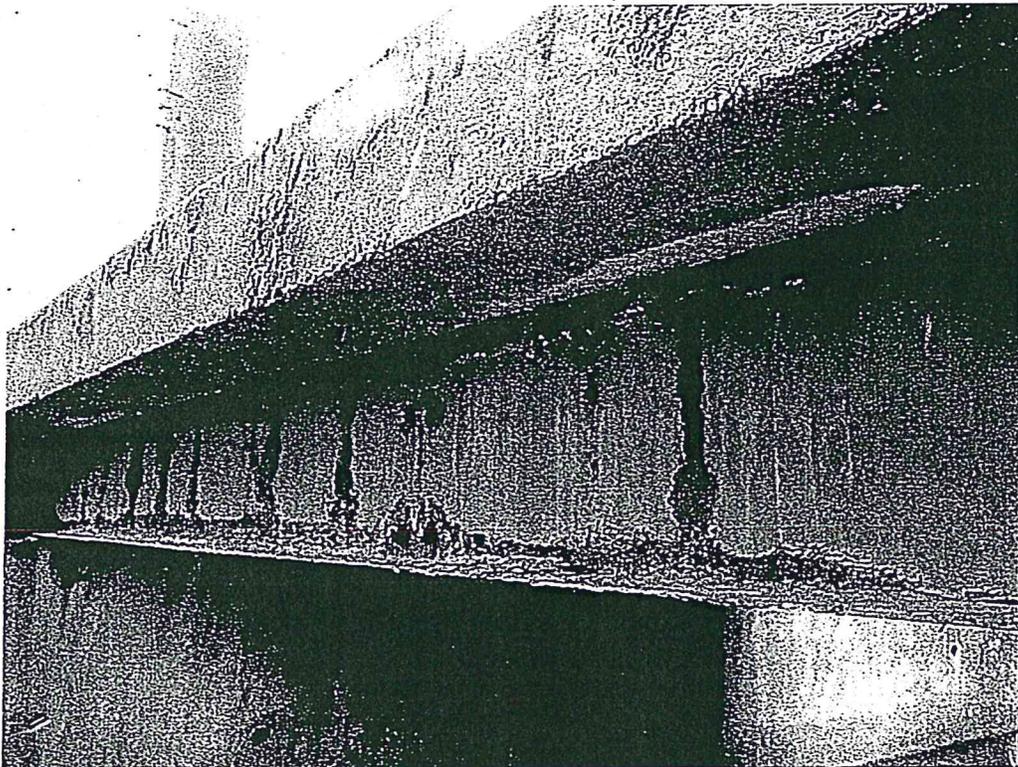
Photo 4: Deterioration of beam 6.

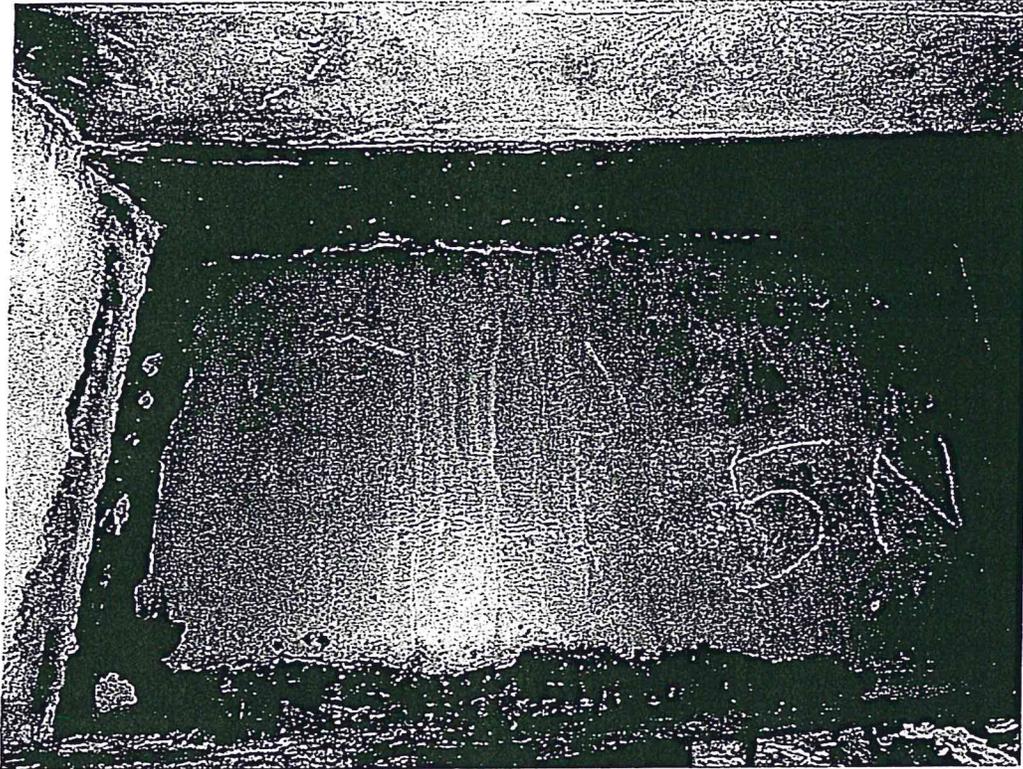
Photo 5: Typical beam end deterioration. Beam 5 at the north end shown.

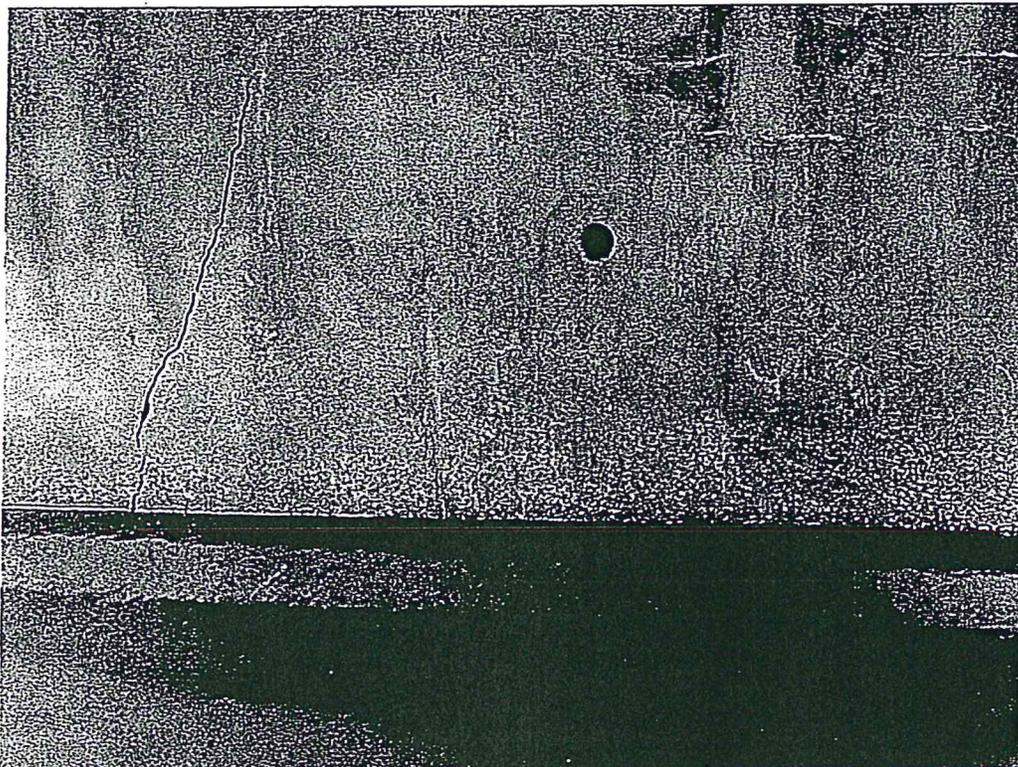
Photo 6: South abutment settlement cracks in the wall and footing.
